Microwave & Electronic Light Control Fix

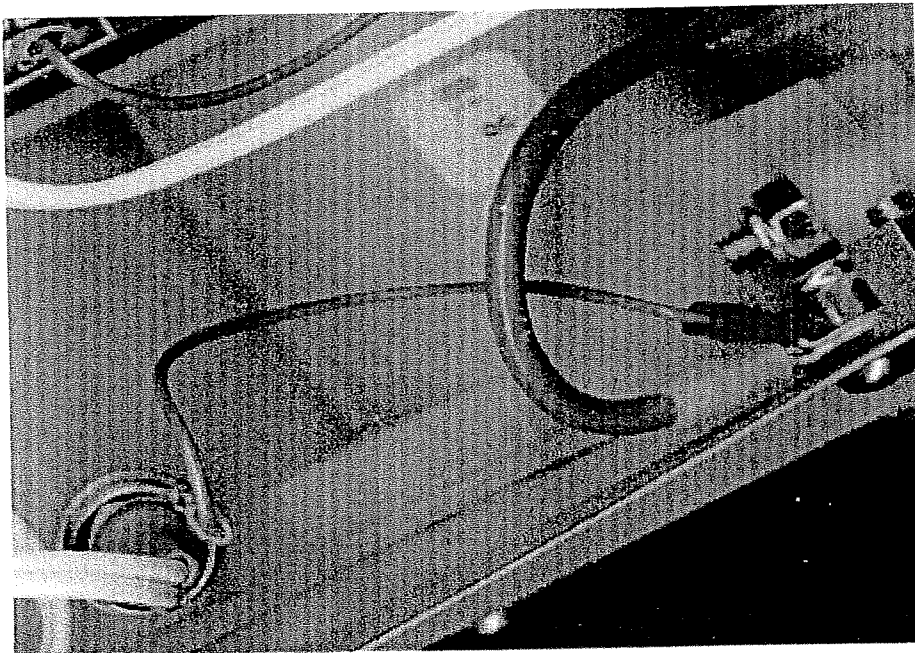
The kit includes a clamp and a piece of wire. The clamp fastens the wire to the base of the second temp sensor (Th-2). The other end of the wire is connected to the ground lug located in the bottom of the unit. No wires are removed to install this kit.

The problem occurs when a microwave or electronic light control create a signal on the same frequency the Seisco uses to monitor its sensors. The Seisco boiler just doesn't know which signal to listen to. The kit when applied enables the Seisco to listen to its own sensors.
